HISTORIC SITES & STRUCTURES SURVEY
Individual Structure Survey Form

1105-31

COUNTY: Rutland
TOWN: Clarendon (Chippenhook)
LOCATION: State Aid Highway 3, intersection with Quarterline Road
FUNCTIONAL TYPE: School
COMMON NAME: Chippenhook School
OWNER: William Russell
ADDRESS: Campbell Road
Rutland, Vermont
ACCESSIBILITY TO PUBLIC:
Yes No Restricted
LEVEL OF SIGNIFICANCE:
Local State National
DATE BUILT:

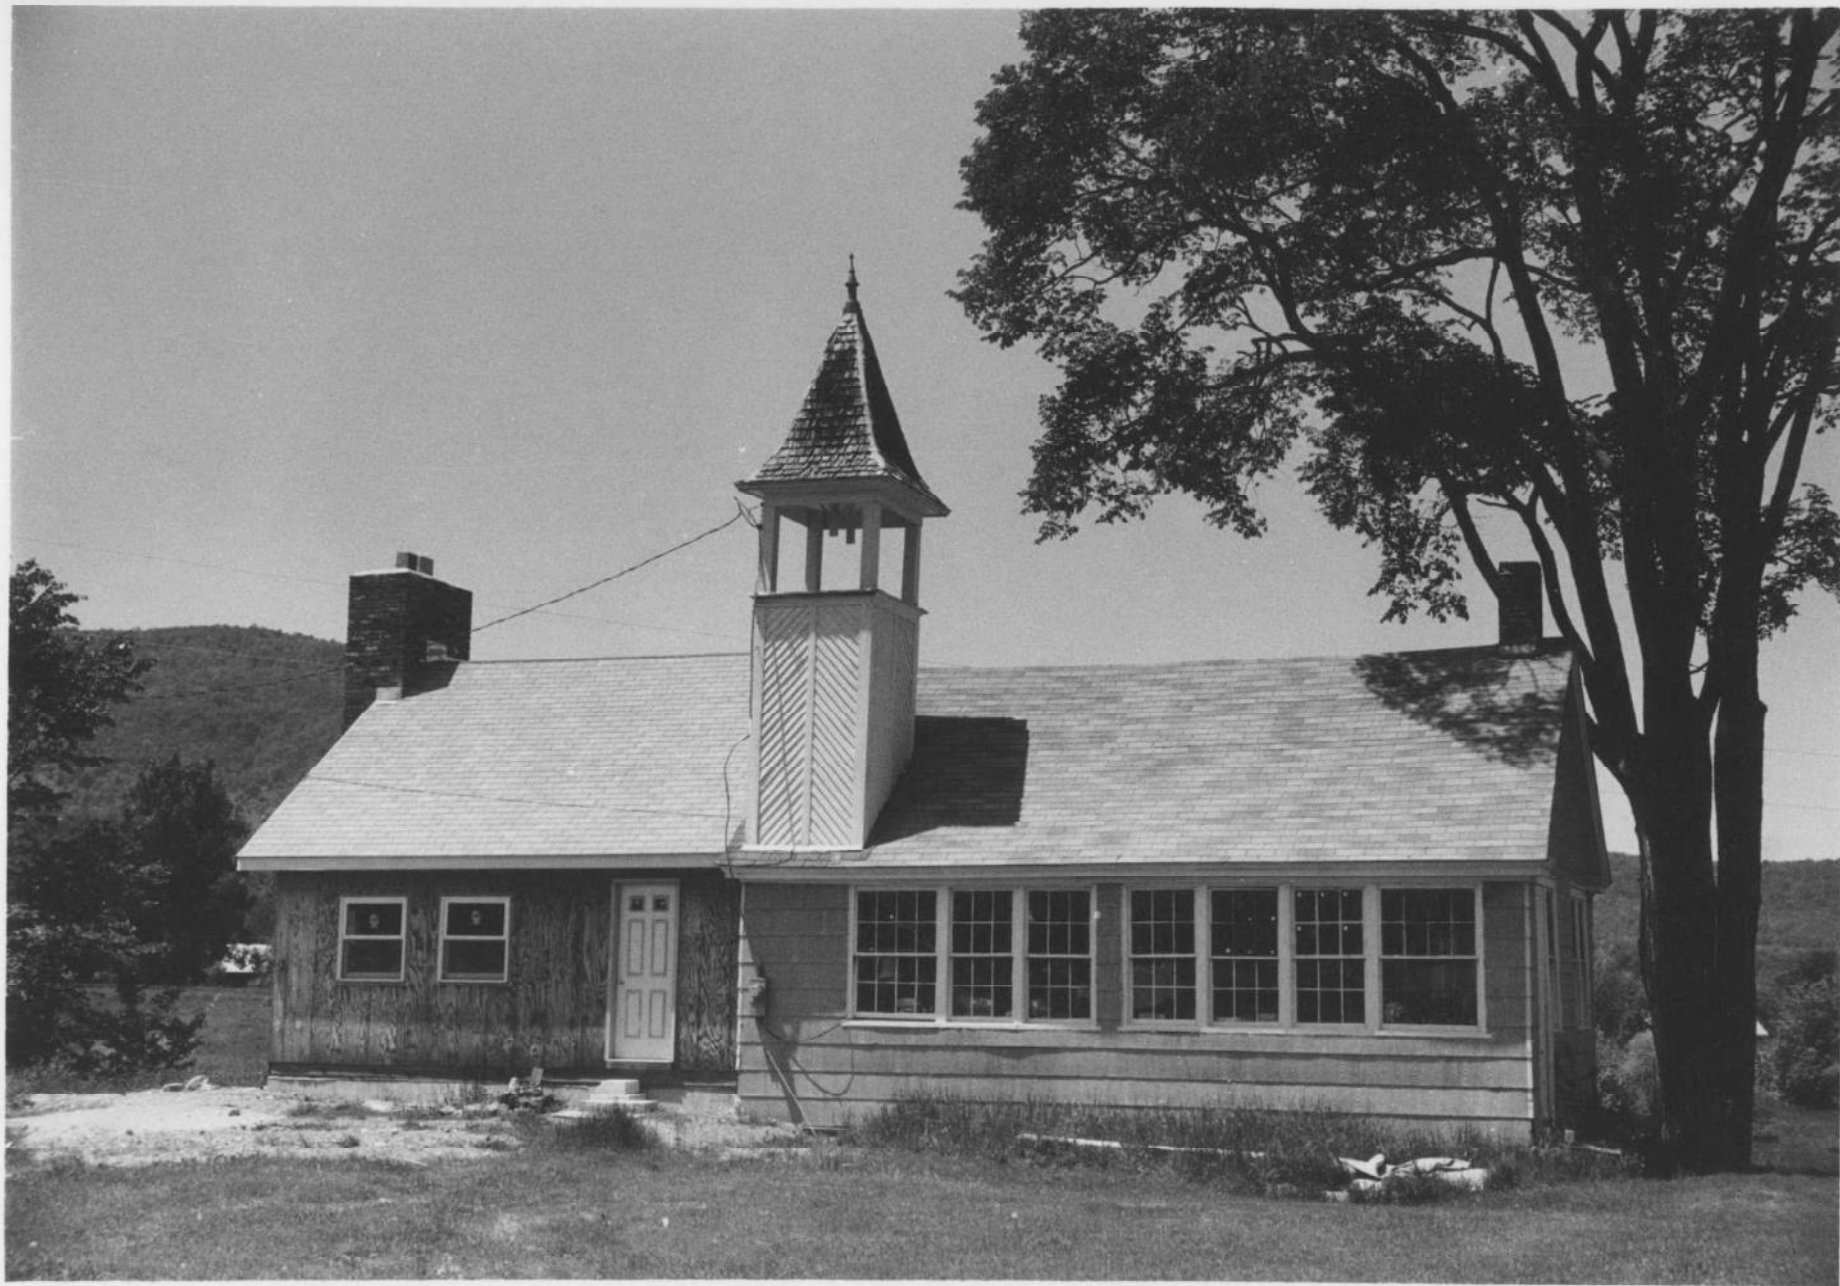
CO. RUTLAND TOWN CLARENDON DATE 6/76
SUBJECT CHIPPEEN HOOK SCHOOL VIEW W
FILE # 76-A-91 CREDIT KATHLYN HATCH

Three-bay east elevation with offset entrance and stove chimney. South elevation has grouped windows, tower with herringbone-patterned base, open belfry, and curved, pyramidal cap. The bell has been removed. A recent addition, related to the conversion of the building to a residence, has been erected at the west, and a new wing at the rear.
