HISTORIC SITES & STRUCTURES SURVEY
 Individual Structure Survey Form

SURVEY NUMBER: 1105-24		
NEGATIVE FILE NUMBER: 76-A-92		
UTM REFERENCES		
18 Zone	665730 Easting	4825460 Northing
U.S.G.S. QUAD. MAP: Rutland Quad., 7.5' Series		
PRESENT FORMAL NAME:		
ORIGINAL FORMAL NAME:		
PRESENT USE: Dwelling		
ORIGINAL USE: Dwelling		
ARCHITECT/ENGINEER:		
BUILDER/CONTRACTOR:		
PHYSICAL CONDITION OF STRUCTURE: Excellent <input type="checkbox"/> Good <input checked="" type="checkbox"/> Fair <input type="checkbox"/> Deteriorated <input type="checkbox"/>		
THEME:		
STYLE: Federal/Greek Revival

COUNTY:	Rutland
TOWN:	Clarendon (No. Clarendon)
LOCATION:	Old Route 7
FUNCTIONAL TYPE:	Residential
COMMON NAME:	
OWNER:	Paul Shedd
ADDRESS:	No. Clarendon, Vermont
ACCESSIBILITY TO PUBLIC:	Yes <input type="checkbox"/> No <input checked="" type="checkbox"/> Restricted <input type="checkbox"/>
LEVEL OF SIGNIFICANCE:	Local <input checked="" type="checkbox"/> State <input checked="" type="checkbox"/> National <input type="checkbox"/>
DATE BUILT:	ca. 1830's

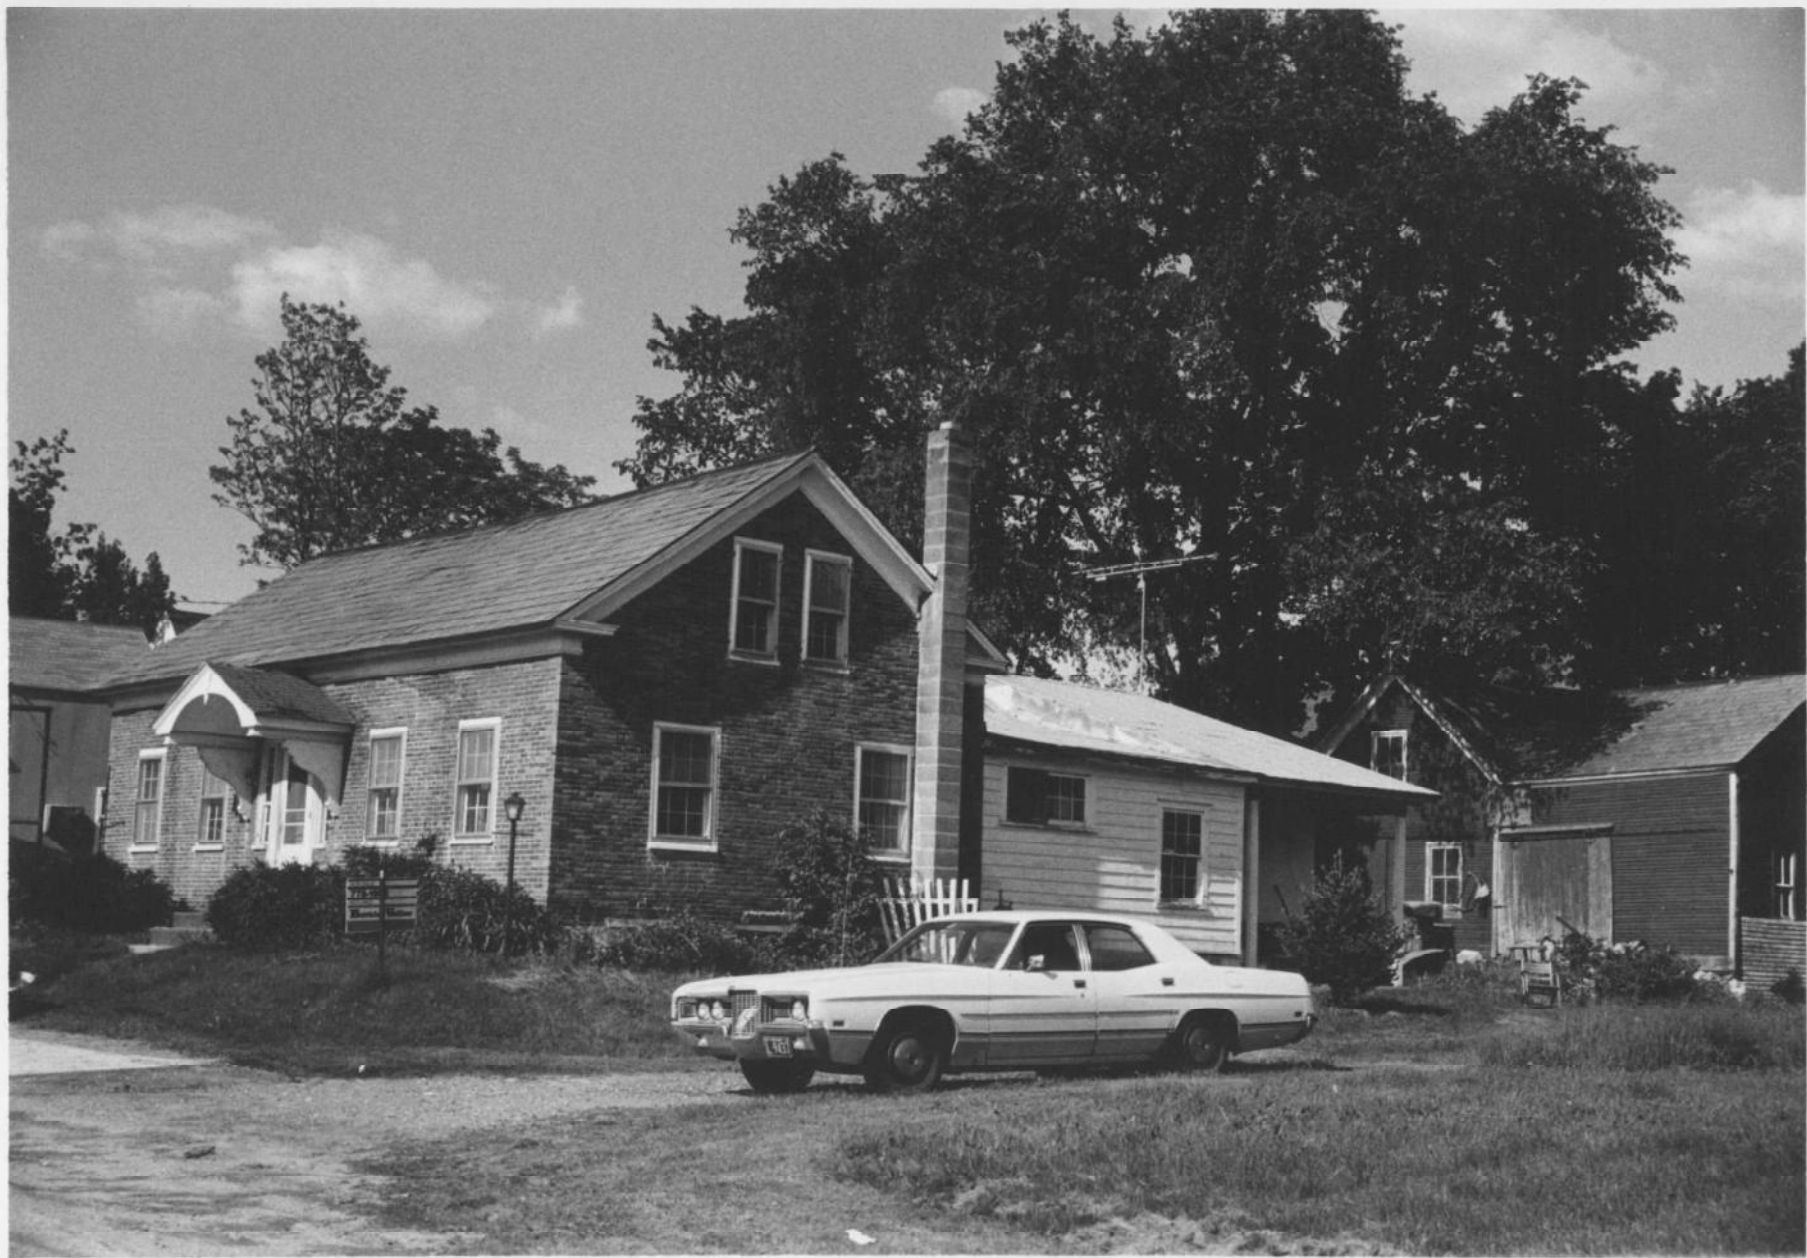
1105-24

Five-bay facade with center entrance. Gabled hood with arched soffit over entrance, which has three-quarter length sidelights, fluted enframement and jambs, and corner blocks. 6/6 windows with molded casings; no lintels. Box cornice with fascia board and returns. Two bays deep. Rear wood frame ell. Common bond brickwork.

CO. RUTLAND TOWN CLARENDON DATE 6/76
SUBJECT SHEDD RESIDENCE VIEW NW
FILE # 76-A-92 CREDIT KATHLYN HATCH
