HISTORIC SITES & STRUCTURES SURVEY
Individual Structure Survey Form

1105-25

COUNTY: Rutland
TOWN: Clarendon (No. Clarendon)
LOCATION:
FUNCTIONAL TYPE: Commercial
COMMON NAME: No. Clarendon Texaco
OWNER: Sumner Page, Hazel Stork,
ADDRESS: Katherine Horvath
No. Clarendon, Vermont
ACCESSIBILITY TO PUBLIC:
Yes No Restricted
LEVEL OF SIGNIFICANCE:
Local State National
DATE BUILT: ca. 1925

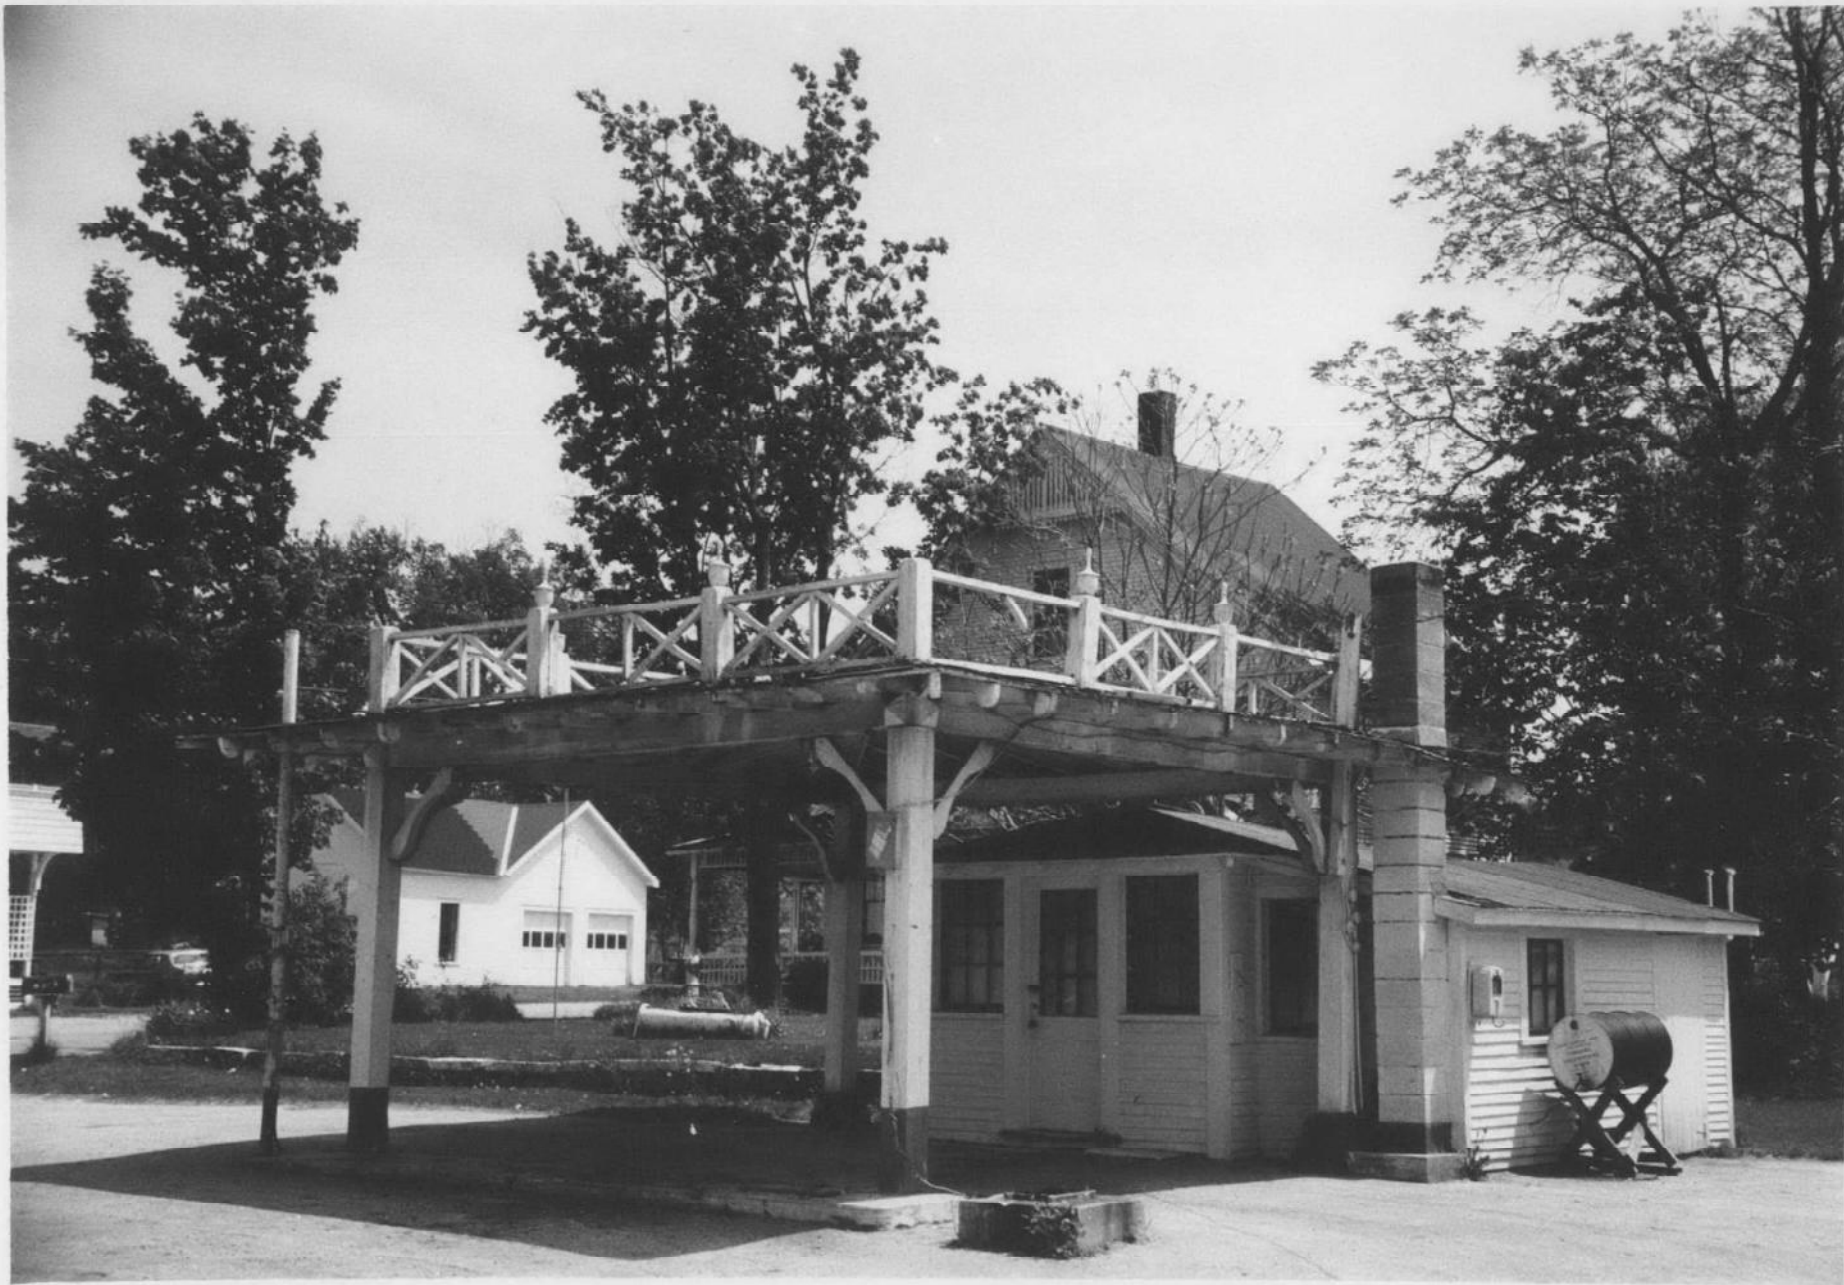
1105-25

Three bays wide, two bays deep. Front service canopy with hip roof, wood posts, balustrade and urn finials. Narrow attached shed with rolled asphalt roof at south wall.

CO. RUTLAND TOWN No. CLARENDON DATE 6/76
SUBJECT GAS STATION VIEW E
FILE # 76-A-90 CREDIT KATHLYN HATCH
